### **ZIMMERIT DAMAGE to Panther Ausf. G Cuckoo (4th Battalion, Coldstream Guards, October 1944 to February '45)**

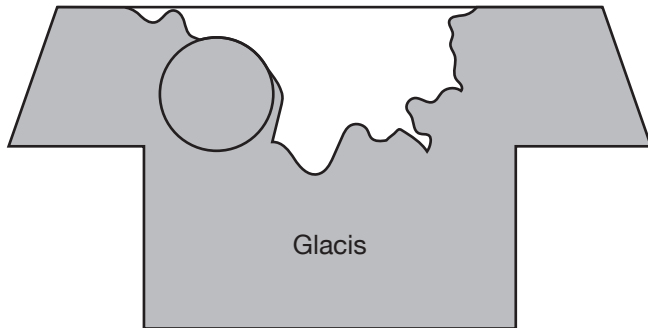
The grey areas indicate the part covered in Zimmerit, which had chipped off the upper centre area between the machine gun ball mount and driver's periscope, and also from the middle of the left turret side. The area behind where the tube on the left hull side should be, was also clear of Zimmerit.

Drawn to 1:35 scale. For other scales, print out at: —
